# Potential tree species for use in urban areas in temperate and oceanic climates

Scholz, M, Uzomah, V C and Al-Faraj, FAM

Heliyon 2 (2016) e00154

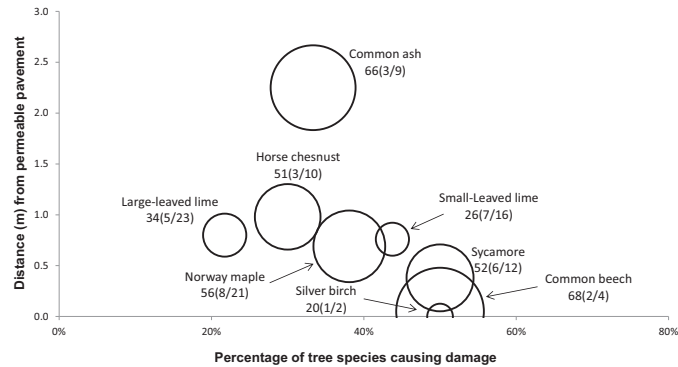
**Fig. 2.** Relationships of tree diameters at breast height (DBH (cm); represented by circles), average distances of trees away from permeable pavements, and the proportion of trees within 10 m to these structures subjected to moderate to severe damage. Note: x(y/z), where x represents DBH and z indicates the number of the tree species out of which y trees caused damage.

Fig. 2, Fig. 3, Fig. 4, Fig. 5, Fig. 6, Fig. 7, Fig. 8 show the relationship of tree DBH, average distance of trees away from the structures, and the proportion of trees close to structures that caused moderate to severe damage. Note that only moderate and severe damage was considered, considering that the reason for light damage is often unclear. Apart from tree-related damage, other reasons for damage might be as important but only further destructive tests on site might reveal the main reason(s) for damage.

For  $x(y/z)$ , where  $x$  represents the DBH (cm), which is also signified by the relative size (diameter) of the circle. The diameters expressed by circles give a visual indication of the maturity of the average tree species, which makes visual comparisons between trees easier. The entry  $z$  indicates the number of the tree species within 10 m of the structure, out of which  $y$  trees caused moderate to severe damage.

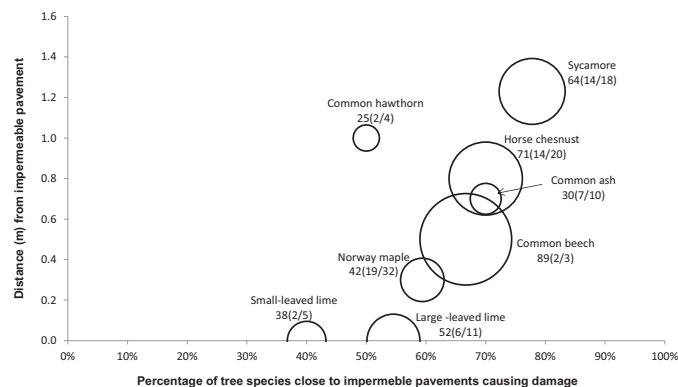
**Fig. 3.** Relationships of tree diameters at breast height (DBH (cm); represented by circles), average distances of trees away from impermeable pavements, and the proportion of trees within 10 m to this structure subjected to moderate to severe damage. Note: x(y/z), where x represents DBH and z indicates the number of the tree species out of which y trees caused damage.

For permeable pavements, most significant ( $p < 0.05$ ) damage to permeable pavements was caused by trees located within 0–1.0 m away from a structure, except for those from *F. excelsior*. About 33% of *F. excelsior* located close to permeable pavements caused damage to these pavements if their average diameter was 66 cm and if their average distance was 2.3 m away from the permeable pavements (Fig. 2). The trees with the highest percentage of moderate and severe damage to permeable pavements (up to 50%) were *F. sylvatica*, *A. pseudoplatanus* and *B. pendula*. However, the corresponding sample sizes were rather small. The average distance of *F. sylvatica* and *B. pendula* to permeable pavements was 0 m, indicating that most of these two species were planted too close to the pavement. The average DBH of these trees was 68 cm and 20 cm, respectively (Fig. 3).

For an impermeable pavement, the further away the tree (up to a distance of 1.4 m), the higher is the percentage of this tree causing damage irrespective of the tree DBH (Fig. 3). This is rather unexpected, considering that a large tree DBH is usually linked to large roots, which would cause damage at close range. However, the tree DBH variability is relatively small and the sample sizes are rather small as well. Regression analysis did not reveal any significant findings.

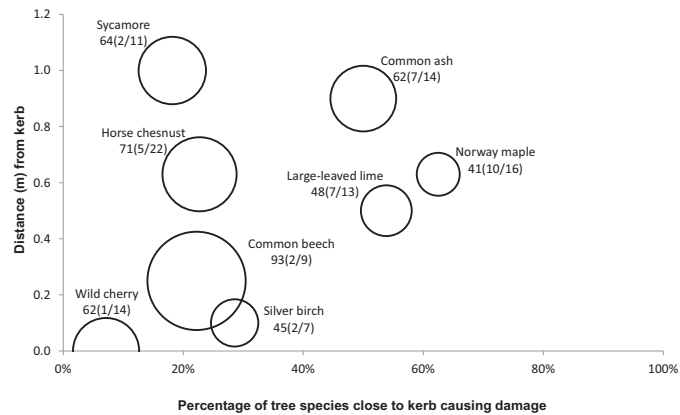
**Fig. 4.** Relationships of tree diameters at breast height (DBH (cm); represented by circles), average distances of trees away from kerbs, and the proportion of trees within 10 m to these structures subjected to moderate to severe damage. Note:  $x(y/z)$ , where  $x$  represents DBH and  $z$  indicates the number of the tree species out of which  $y$  trees caused damage.

Kerb damage comprised 19% of all recorded structural damage. *Acer platanoides* caused the most damage to kerbs (10 out of 16 trees were located close to kerbs) from an average distance of 0.6 m and with a mean DBH of 41 cm (Fig. 4). Similar to *A. platanoides* was the impact of *T. platyphyllos* (7 out of 13 nearby *T. platyphyllos*), *A. pseudoplatanus* (2 out of 11 surrounding trees) and *F. excelsior* (7 out of 14 surrounding trees) caused damage to kerbs from the furthest average distance of 1 m (Fig. 4).

Other trees that caused damage were less than 1 m from the kerb as shown in Fig. 4. *Prunus avium* was the best tree suitable for kerbs: only 1 in 14 trees caused moderate to severe damage (Fig. 4). However, most *P. avium* were very closely located (0 m) to kerbs, and their average DBH was 62 cm. This was closely followed by *F. sylvatica*. Although for *F. sylvatica* of an average DBH of 93 cm (indicating trees well-advanced in age) and an average distance of 0.23 m from kerbs, only 2 out of 9 trees caused moderate to severe damage to kerbs (Fig. 4). The worst tree to be located close to kerbs is *A. platanoides*. For trees of this species with an average DBH of 41 cm (indicating middle age) and located about 0.6 m from the kerbs, about 10 out of 16 *A. platanoides* caused moderate to severe damage to kerbs (Fig. 4).

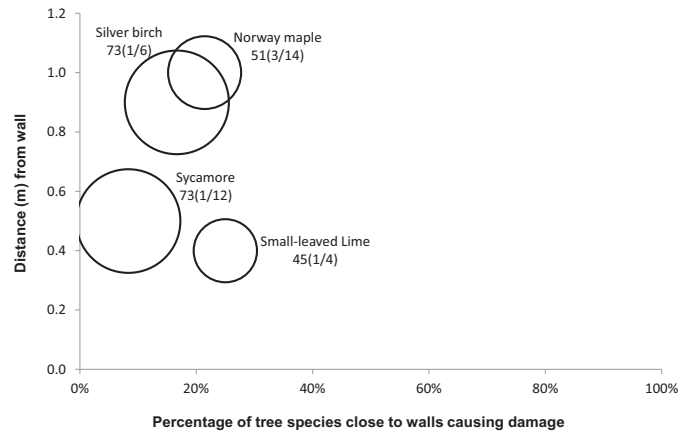
**Fig. 8.** Relationships of tree diameters at breast height (DBH (cm)); represented by circles), average distances of trees away from walls, and the proportion of trees within 10 m to these structures subjected to moderate to severe damage. Note:  $x(y/z)$ , where  $x$  represents DBH and  $z$  indicates the number of the tree species out of which  $y$  trees caused damage.
