Living with helicopter noise : evaluating sound insulation techniques for domestic dwellings using real helicopters

Kerry, G, Waddington, DC and Lomax1, C

Running title: Living with Helicopter noise

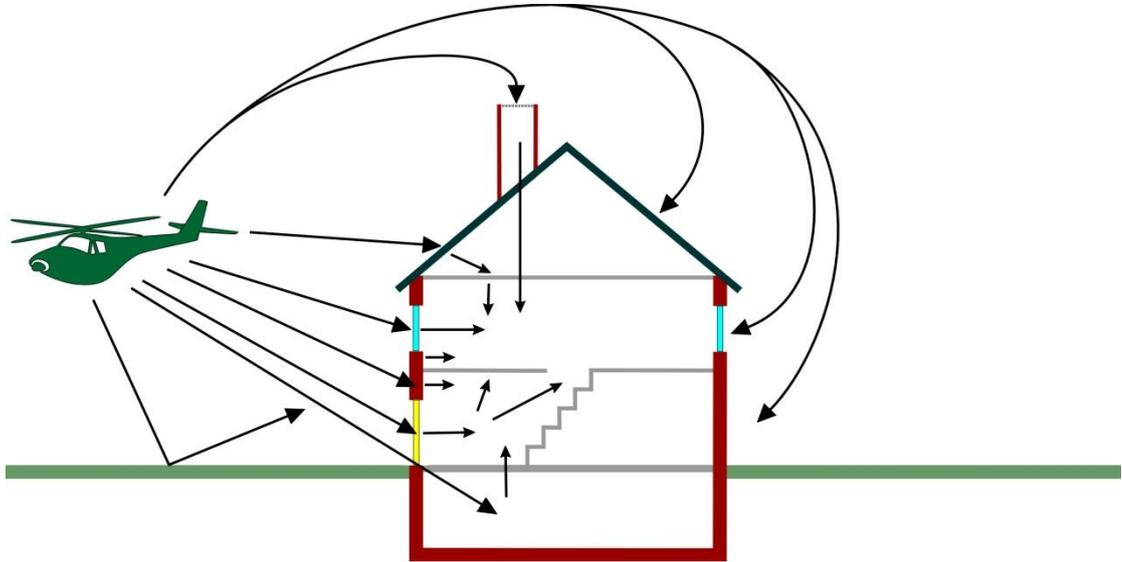
Figure 1: Illustration of sound transmission paths from a helicopter into a residence

Figure 1 illustrates a number of routes by which sound can enter a dwelling. In a conventional UK style brick built house, the walls and substantial roofs usually provide effective sound insulation but single glazed windows, lightweight or badly fitting doors, roof spaces without internal sound absorption (or constructed from lightweight timber/felted sections) and ventilation bricks and conventional chimneys can significantly reduce its effectiveness resulting in intrusive levels of noise in habitable rooms.

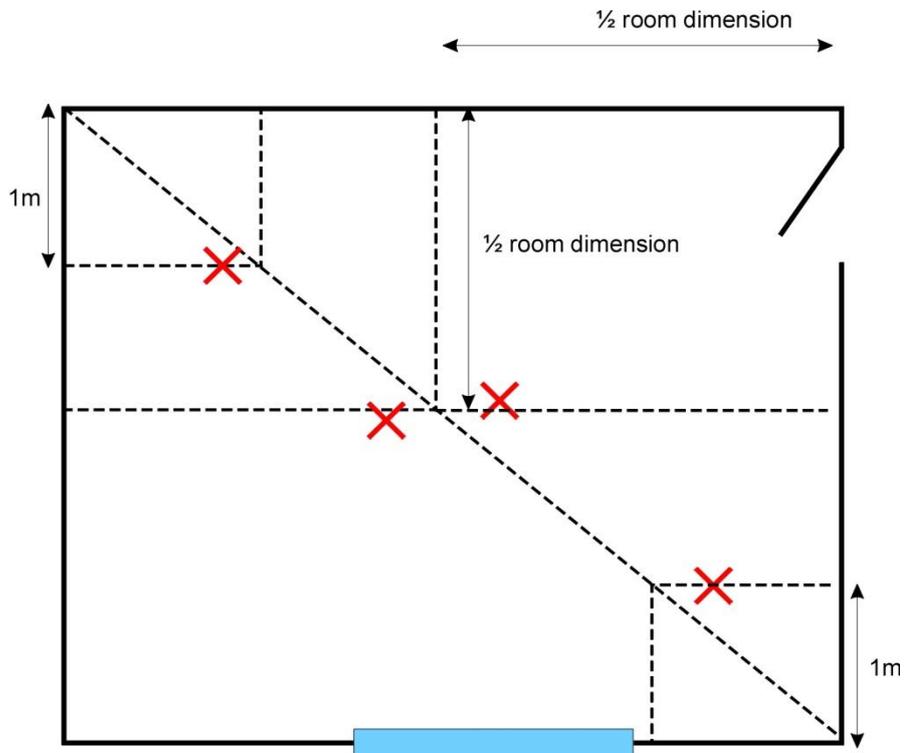
Figure 2 Typical microphone positions

Microphones were placed simultaneously inside and outside selected rooms. Inside, microphone positions were selected to ensure a reasonable spatial average of the flyby level would be obtained and to minimise undue room mode effects. Four positions were defined in each room as shown in Figure 2, chosen initially by drawing an imaginary diagonal across the room and placing the microphone tripods approximately:

1. One metre along the outside wall away from the front window wall and just off the diagonal
2. Half way down the outside wall, just off the diagonal
3. Half way along the window wall and just off the diagonal

4. One metre from the rear wall and from the internal wall

The microphone was fixed vertically on the tripod at either 1.2 or 1.5m above the floor. Usually two positions were selected at each height and the microphone offset ensured that the microphone positions were not symmetrical.

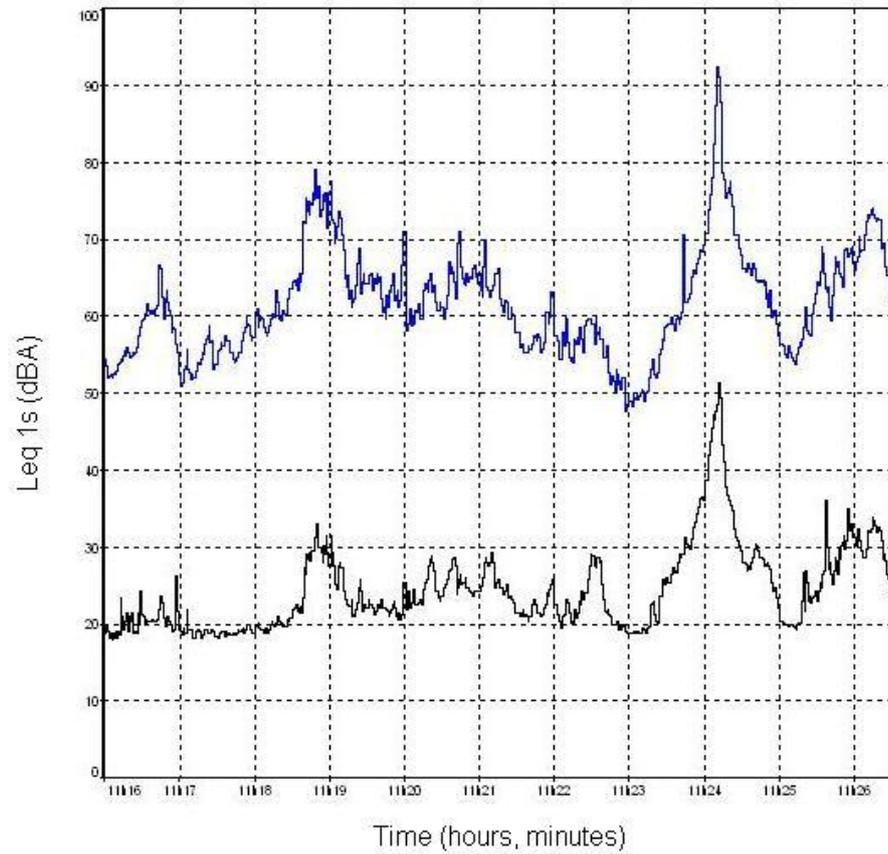
Figure 3: Leq dBA level time histories measured inside and outside the front left bedroom. High level trial flyby used for insulation calculations: 11h24m08 to 11h24m14. Routine operational flyby: 11h16m36 to 11h16m52

was then calculated as the average of these differences.^a An example of a measured time history is shown in Figure 3.

Examples of internal and external noise levels and spectra are given in Figure 3 and Figure 4. The analysis was carried out in 1/3 octave bands but to simplify the discussion the data have been reduced to octave bands and the resultant measured sound insulations plotted in Figure 5. A simple single value measure of the sound insulation is provided by the weighted standardised level difference $D_{H,1m,nTw}$ in Table 2. This has been compiled using the basic 1/3 octave data. The single number quantity term $D_{H,1m,nTw}$ is essentially the same as the term $D_{E,1m,nTw}$ which is derived from the octave $D_{E,1m,nT}$ values. The subscript H has been substituted for E to clarify that the source is a helicopter.

Examples of the time histories of these operational flybys can be seen in Figure 3 alongside examples of the trial flybys. Generally the flyby levels generated outside a dwelling in the vicinity of an airfield or helicopter landing ground will be dependent on the type of aircraft, the type of manoeuvre and the track and distance to the dwelling and the relative amount of shielding that parts of the dwelling itself might provide. The data presented in this section should only be considered as an example of the noise levels that can be expected at this particular property when a particular runway is in use. The results are presented in Table 3 in terms of the A and C weighted equivalent continuous noise level (L_{eq}) over the relevant noisiest part of the flyby and as spectra in Figure 6.

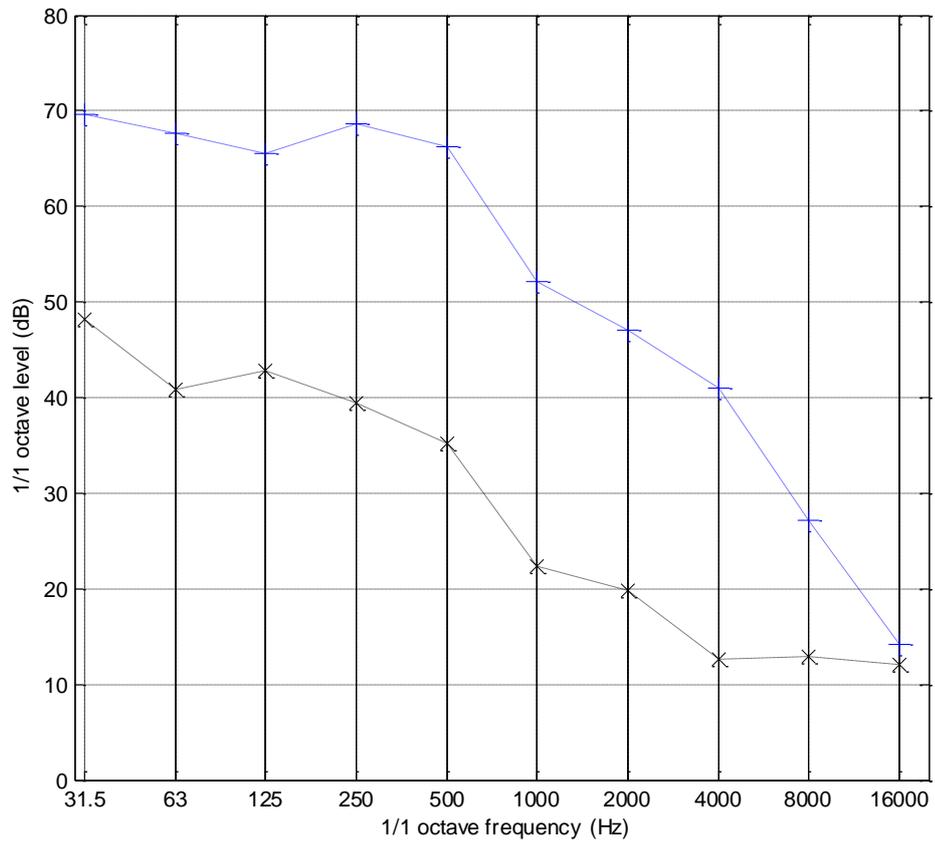
Figure 4: Internal (black) and external (blue) spectra for a typical flyby.

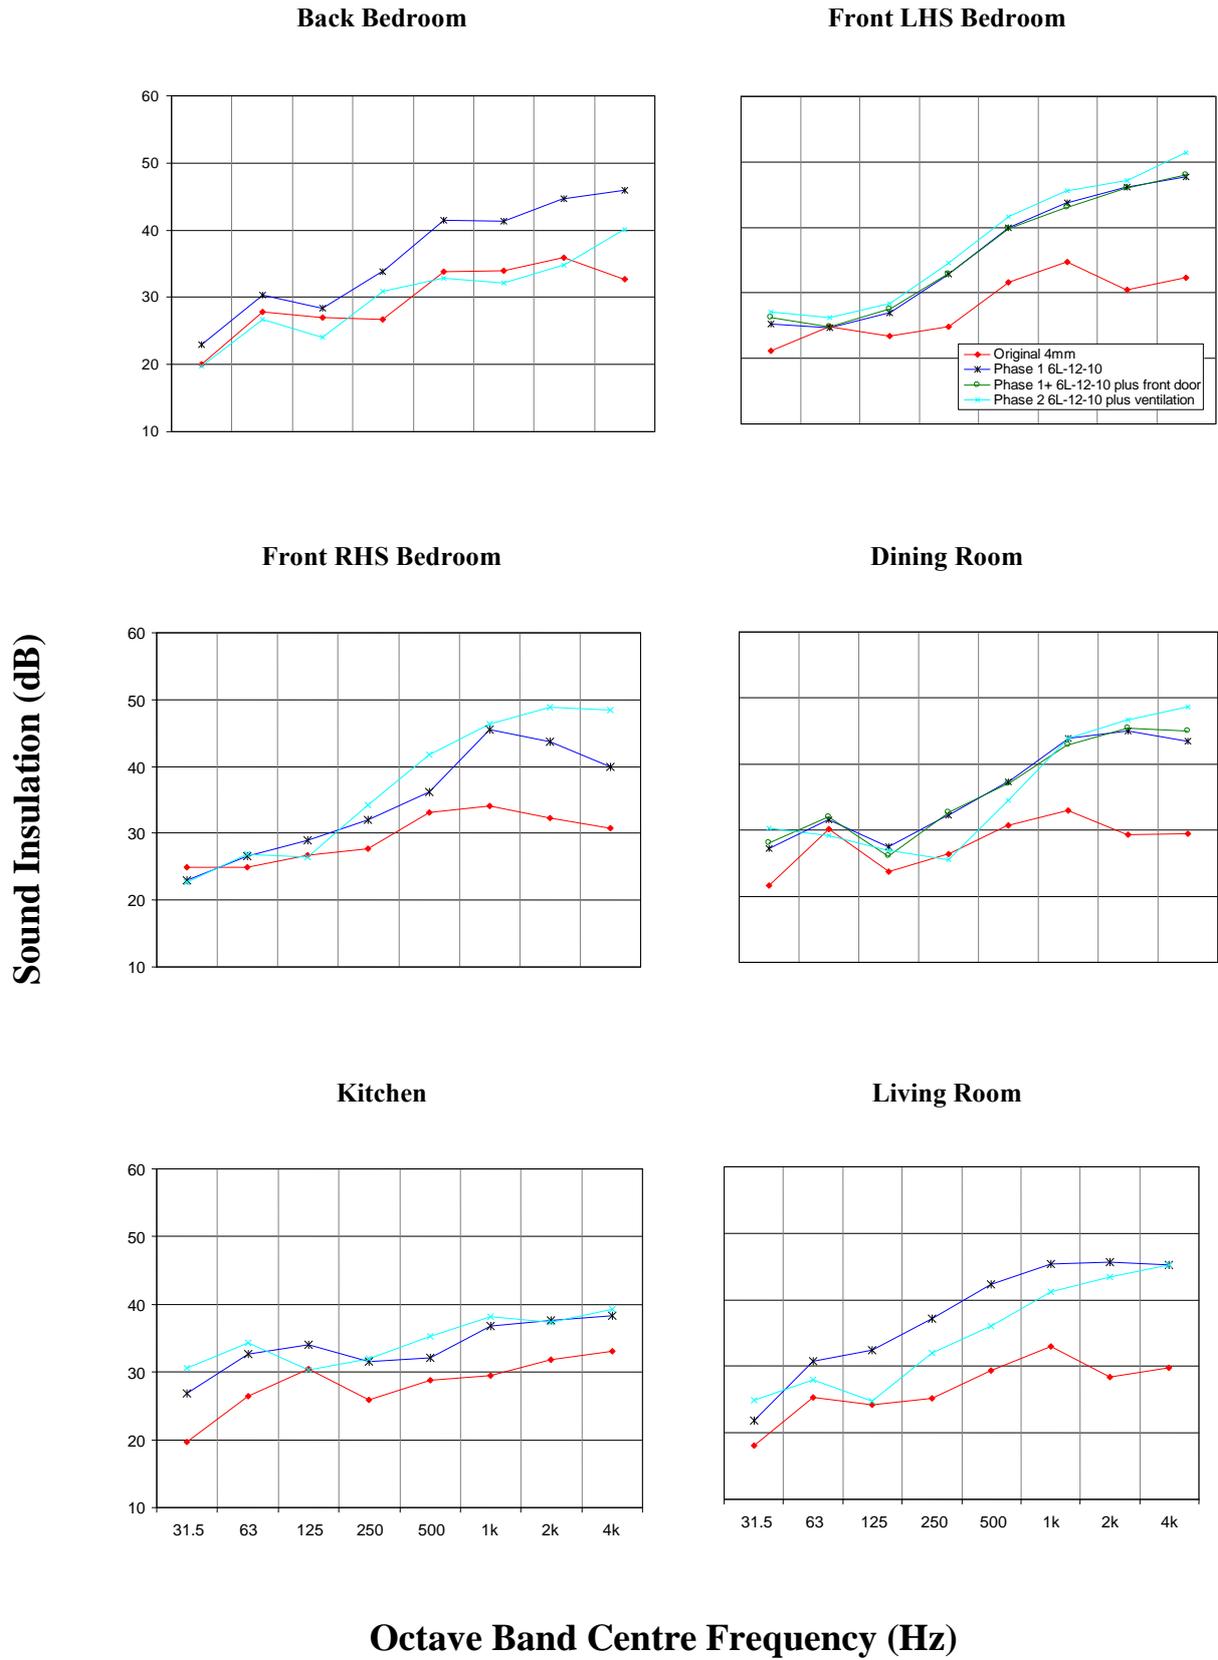
Figure 5: Sound insulation measured in each room

Figure 5: Sound insulation measured in each room

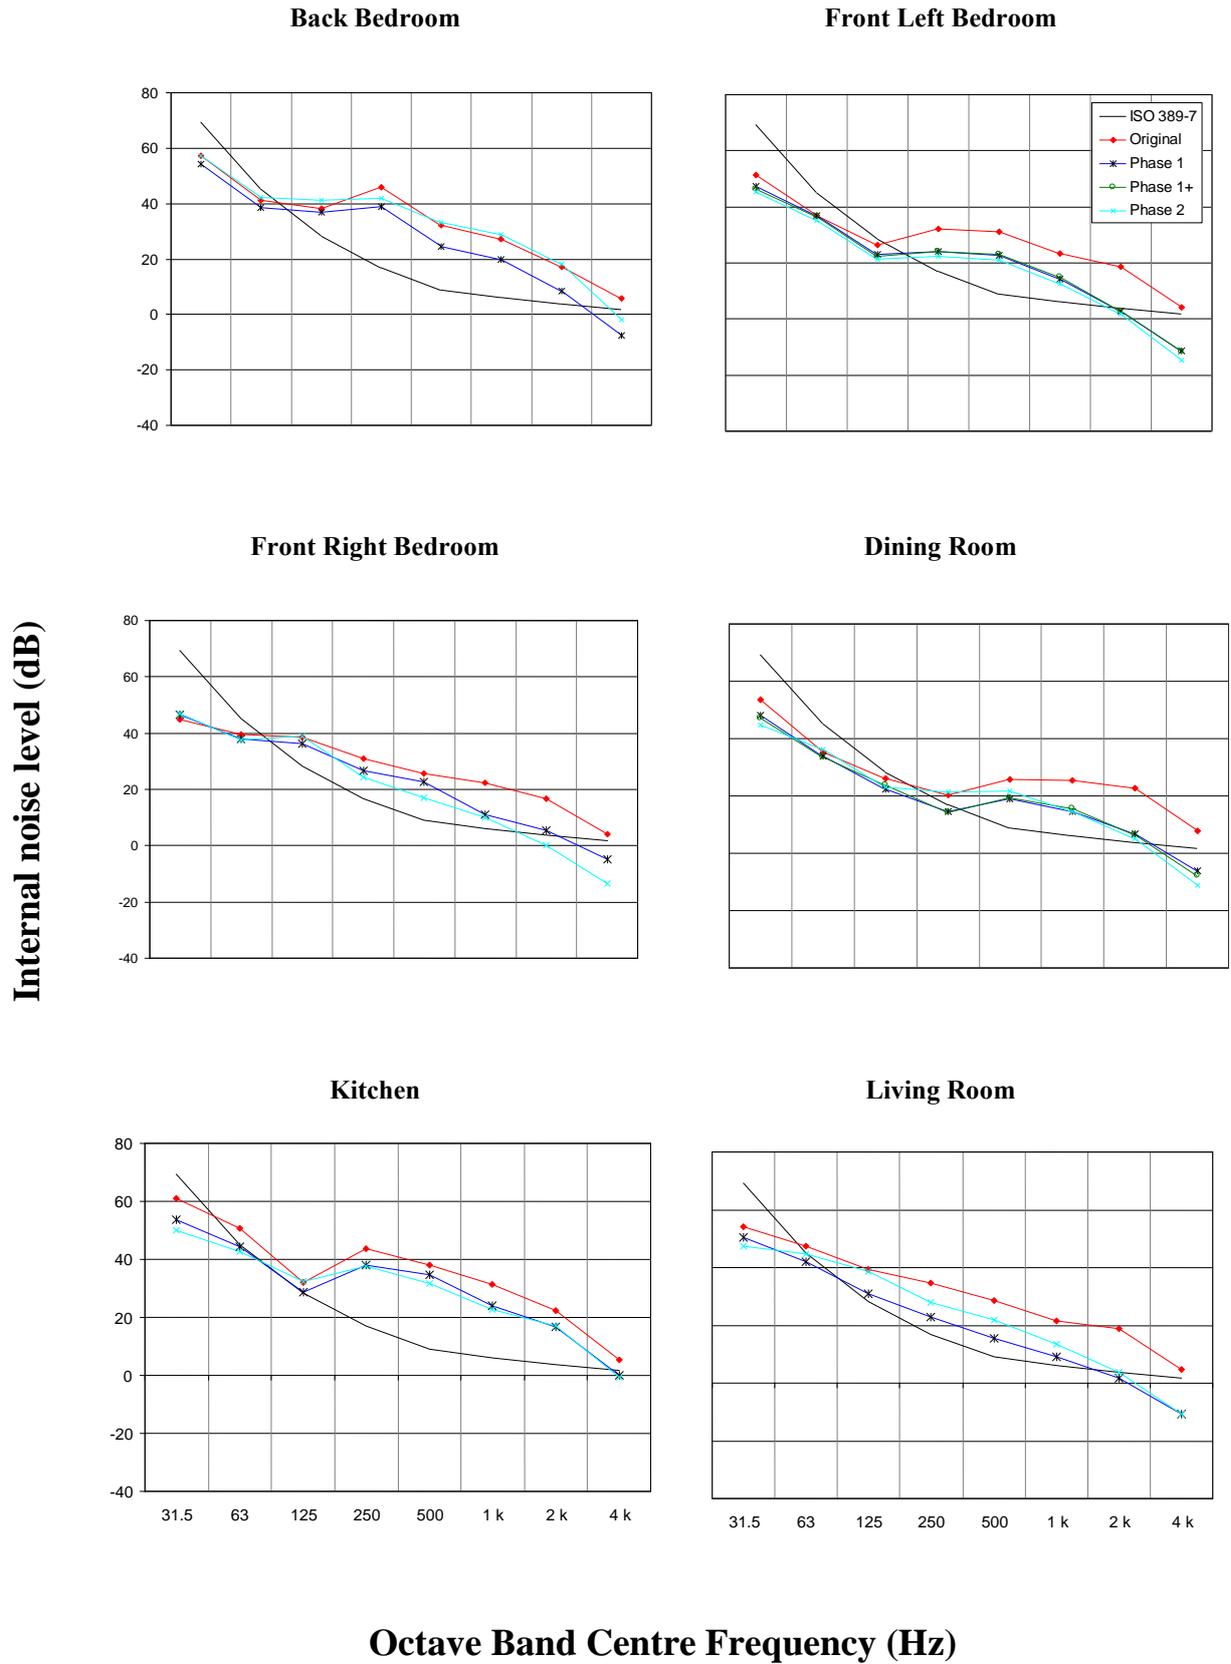
Figure 6: Internal noise level measured in each room

Figure 6: Internal noise level measured in each room
