# Modeling the behavior of radially pinned brick triplets

<b>Title</b>	Modeling the behavior of radially pinned brick triplets
<b>Authors</b>	Haynes, J, Naggasa, A, Augusthus-Nelson, L, El-basir, F and Alsaleh, A
<b>Publication title</b>	Proceedings of ARCH 2019. 9th International Conference on Arch Bridges
<b>Publisher</b>	Springer
<b>Type</b>	Conference or Workshop Item
<b>USIR URL</b>	This version is available at: <a href="http://usir.salford.ac.uk/id/eprint/52738/">http://usir.salford.ac.uk/id/eprint/52738/</a>
<b>Published Date</b>	2019

This paper offers some early results from an investigation of a ring separation repair technique involving radial pinning. Triplet testing is used to establish and compare the structural behavior of two types of shear reinforcement, which are validated by finite element modelling. Conclusions are drawn which are potentially of significant practical interest to masonry arch bridge owners and assessors.

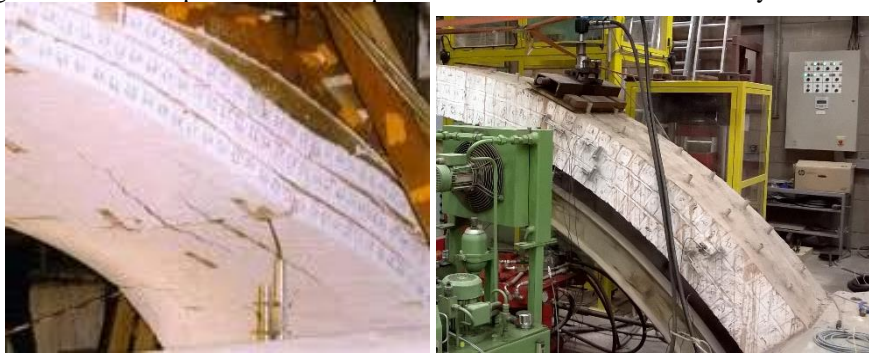
This paper addresses a possible remedial solution to this problem using radial pinning, which is intended to mechanically resist slip between arch rings. Figure 1 depicts ring separation and the proposed repair. Radial pinning is considered to be an advantageous remedial repair because it requires access to the arch intrados only.

Fig. 1. Ring separation and radial pinning.

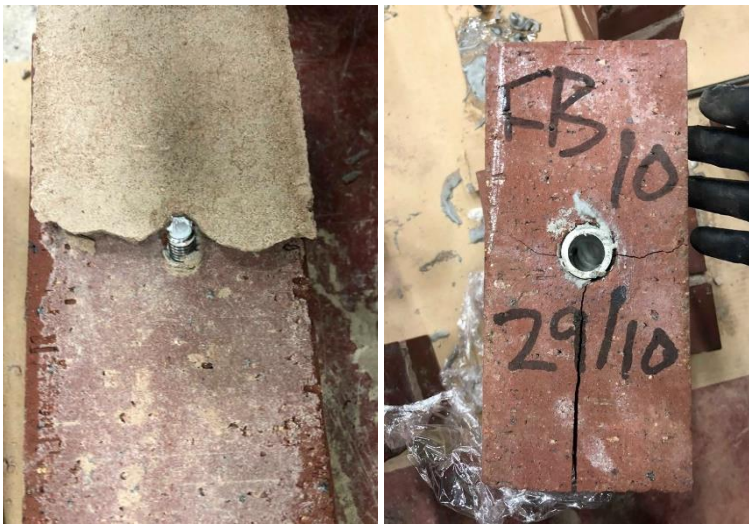
During the test it was observed that distinctly different failure modes occurred in the steel bar and aluminum tube reinforced triplets. As can be seen in Figure 5, the bar reinforced triplets failed by shear of the 10mm diameter steel bar, following cracking between the mortar and bricks. However, the tube reinforced triplets failed by splitting of the brick, following cracking between the mortar and bricks, with little permanent deformation of the 25mm diameter tube.

**Fig. 5.** Failure mechanisms identified in a) bar reinforced, and b) tube reinforced triplets [12].

Testing results suggest that use of a small diameter mild steel bar will produce shear failure in the radial pin but use of a larger diameter radial pin will change the failure mechanism to splitting of the brick.

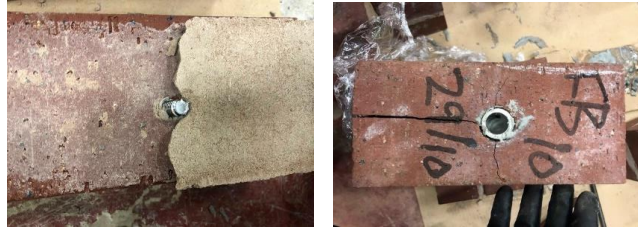
The aluminum tube reinforced triplets failed by splitting of the brick, as can be seen in Figure 1. Initially behavior was similar to an un-reinforced triplet but with much greater failure strain. This suggests that initial response is governed by the mortar stiffness, and once the bond is broken the tube deforms until the shear stiffness of the brick is mobilized.

**Fig. 1.** Failure mechanisms identified in a) bar reinforced, and b) tube reinforced triplets [4].

The steel bar reinforced triplets failed by shear of the bar, exhibiting a near perfect elasto-plastic characteristic, suggesting shear failure of the steel dominates the behavior of the joint.
