# ASSESSMENT OF DISPROPORTIONATE COLLAPSE FOR MULTI-STOREY CROSS-LAMINATED TIMBER BUILDINGS

Hercend Mpidi Bit<sup>1</sup>, Neil Currie<sup>2</sup>, Thomas Tannert<sup>3</sup>

**ABSTRACT:** This paper investigates the risk of disproportionate collapse following extreme loading events. The methodology mimics a sudden removal of a loadbearing wall of a twelve-storey CLT building. The ductility-demand from the dynamic simulation is checked against the ductility supplied by the structural components and their connections. The analyses focus on rotational stiffness ( $k$ ) of the joints by considering three different sub-structural idealisations according to the required modelling details and the feasibility of model reductions. To resist the imposed dynamic forces, the required  $k$ -values may be too large to be practically achieved by means of off-the-shelf brackets and screw connections. Improved structural detailing as well as adequate thickness of structural elements need to be considered in order to reduce the probability of disproportionate collapse.

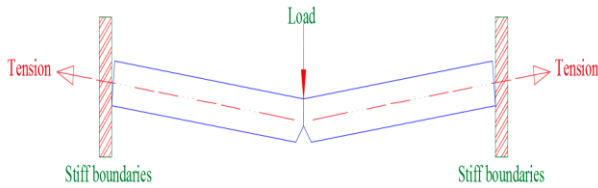
Figure 1 shows catenary action as an example of resistance mechanism. It enables for suspension of the floor above the ineffective vertical loadbearing element, hence avoiding debris loading on the floor below. To be able to hang, the components shall carry tension forces. These forces have to be compatible with the amount of deformation, expressed in terms of rotation, required at connection level [7]. For adequate design, the requirements for robustness are embodied within design Standards, providing guidance against disproportionate collapse.

**Figure 1:** Floor elevation showing catenary action

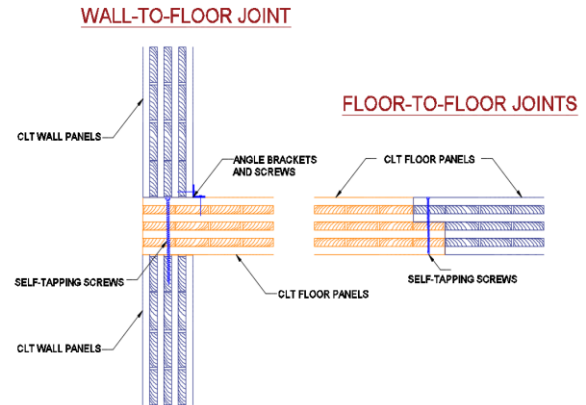
The aim of the study was to verify whether the twelve-storey building would be able to maintain its structural integrity after the loss of the internal ground floor loadbearing wall. Assuming adequate continuity is provided, as the structure did not have many vertical elements, focus was on rotation ductility in order to achieve a system with sufficient structural integrity. Here, this was expressed in terms of rotational stiffness of the connections. Figure 3 shows the chosen structural detailing used for the wall-to-floor and floor-to-floor joints. This was the same detailing provided for the Stadthaus apartment.

Figure 3: Structural detailing of joints

It was assumed that the joints would control the overall strength and stiffness of the building; therefore the loads and deformation at joint level, following extreme loadings, would be taken as the demand. Comparison was made against strength and deformation supplied by the provided connections. Disproportionate collapse could only be avoided if the supply was higher than the demand and the resulting deformations was smaller than the collapse thresholds. These were assumed to be 10% of the floor span, representing 900mm as vertical deformation at mid-span.

For first detailing, off-the-shelf angle brackets with screws were used to connect the floor and the wall above. The minimum screws patterns, according to the European Technical Approval ETA-06/0106, were followed [20]. Angle brackets 90mm wide without rib were placed at 500mm centre to centre. Self-tapping screws, ASSY 3.0 [21], were used to connect the floor and the wall below. These screws had 8mm diameter, located at 500mm centre to centre, and inserted at 90-degree to the CLT panel to act in shear under the floor loadings. The same configuration, using self-tapping screws, was used for the second detailing to connect the two floor panels.

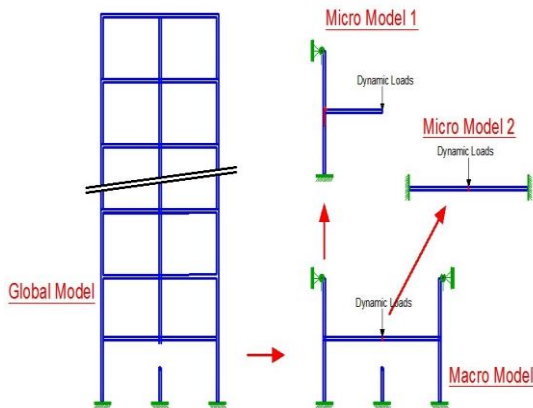
Finite Element Analyses (FEA) were performed in Ansys 12 [22]. As shown in Figure 4, the method was a multi-level assessment where investigations were done at three different sub-structural idealisations; which were global, macro and micro levels. The modelling details and complexities dictated the feasibility of the model reductions. At the Global level, focus was on the overall structural behaviour of the building in terms of load combinations, deflected shape, vibrations frequencies, mode shape and damping ratio. It is on this model that the internal wall was removed instantaneously to trigger the dynamic effect on the structure. This level of idealisation defined the magnitude of the forces transferred to the joints at every storey as well as the associated deformations. The FEA results obtained at this stage were considered as the demand on the structure. Since this was the upper bound, it was assumed that the joints were fully restrained, and CLT elements were taken as linear orthotropic.

Figure 4: Multi-level assessment approach

With appropriate boundary conditions, provided that surrounding structural elements could redistribute the forces after the removal of the internal wall, a reduction to micro models was possible. Taking advantage of symmetry, the Micro-models 1 and 2 were idealised to understand the contribution of the detailed joints. First, 3D-models were constructed, with all screws and angle brackets, to capture a realistic behaviour of the connection. This was important as the failure of the floor is largely influenced by the maximum deformations as well as forces that the joint could carry. Results from these models were considered as the supply; which needs to be compared against the demand from the global model. For this reason, the 3D-models, the lower bound, considered the contribution of different layers within the CLT panels, assuming they would always be bounded to reduce nonlinearity. Linear orthotropic material properties were used for CLT elements whereas the screws and angle brackets used a bi-linear backbone curve. Also, with the high forces from the global-model, the analysis accounted for large deformations.

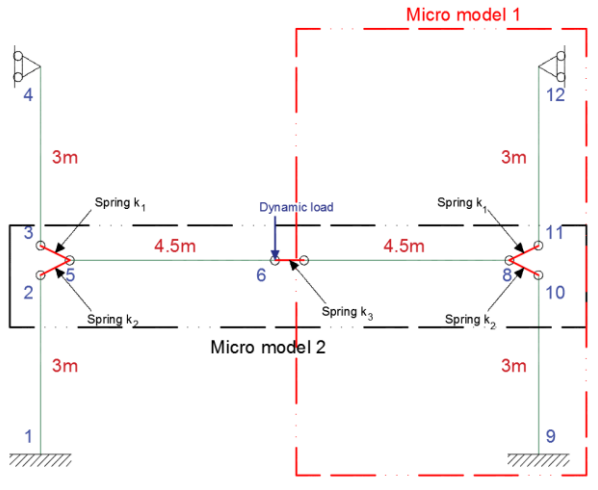
Figure 5: Boundary conditions for Macro model

Figure 5 illustrates the boundary conditions used for modelling at the 2D Macro-model. The locations of nodes were numbered from 1 to 12. Nodes 2, 3 and 5 (similarly 8, 10 and 11) had the same coordinate and were constrained in the two orthogonal directions,  $x$  and  $y$ . This enabled them to have the same deformations. The same constraints were used for nodes 6 and 7. In addition, only the permanent loads from the floors above acted as favourable load on node 4 and 12 to improve the resistance of the sub-frame. From the Macro-model shown in Figure 5, both Micro-models 1 and 2 were extracted. However, for the latter, fully fixed boundaries were assigned at node 5 and 8 to emphasise on the rotational stiffness between the two panels.

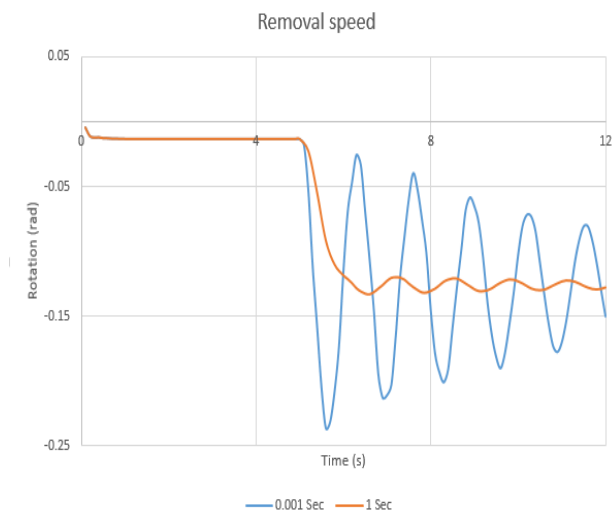
The first analysis considered 0.001sec as speed of removal ( $t$ ) and 3% critical damping ratio. Figure 7 shows how the floor oscillate after the sudden removal of the internal wall. Illustrating the rotation, 0.90m away

from wall-to-floor connection. Here, the maximum rotation was found to be 0.24rad, giving a vertical deformation of 0.91m at the location of the removed wall. These values were obtained 0.7sec after removal. Furthermore, the difference between 3% and 5% critical damping ratio, with respect to forces and deformations, was small hence could be neglected. For both 3% and 5%, 7sec were not sufficient for the structure to regain a static equilibrium. This was only possible with a critical damping ratio above 30%. Since the analysis considered linear material properties, the equilibrium geometry from dynamic solution would be the same as the static analysis of the structure without the internal wall.

Figure 7 also emphasises the difference of the structural response with respect to the speed of removal of the internal wall. Here, comparison was made between 0.001sec and 1sec, a bigger rotation, associated with high dynamic motions, was obtained for quicker removal. The graphs also confirm the fundamental period of the structure, 1.3sec, which correlated well with the results obtained from the modal analysis.

**Figure 7:** Joint rotation and speed of removal

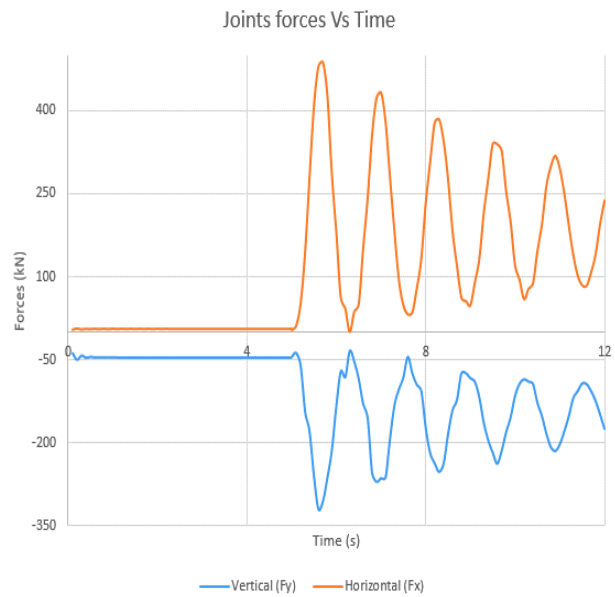
Figure 8 shows the behaviour of forces at wall-to-floor connection for 0.001 sec as speed of removal. The maximum shear ( $F_y$ ) and axial ( $F_x$ ) forces were 321kN and 487kN, respectively. Both were obtained 0.7sec after removal. Furthermore at the location above the removed element, on one side of the span only, the shear forces on the floor changed from downward 51kN to upward 181kN. With sufficient time for damping, at the equilibrium geometry of the structure, the shear converged to downward 50kN. With the new load-path, the floor loads was transferred to the external walls. The maximum compression load on those elements increased from 1242kN, before removal, to 3481kN after removal.

**Figure 8:** Forces at joint level

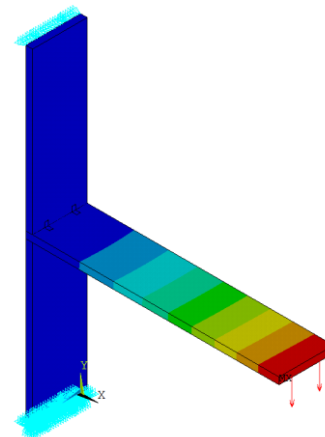
**Figure 9:** Vertical deformed shape of 3D micro model 1

The 3D model shown in Figure 9 had convergence problems; only 44% of the vertical dynamic loads from the global model could be applied. From this model, the rotational stiffness for  $k_1$  and  $k_2$  were estimated to 211kNm/rad and 359kNm/rad, respectively. The deformed shape of the model gave a maximum joint rotation of 1.14rad. The 2D-model was calibrated from the 3D-model in order to estimate the rotational stiffness demand. It was found that a rotational stiffness of 10<sup>6</sup>kNm/rad, for both  $k_1$  and  $k_2$ , would be required in order to take the full dynamic loads. Nevertheless, as shown in Figure 10, the rotation at 0.9m from the wall-to-floor could not go beyond 1.14rad, taken as the maximum rotation. Hence the considered changes had no influences on the outcome.

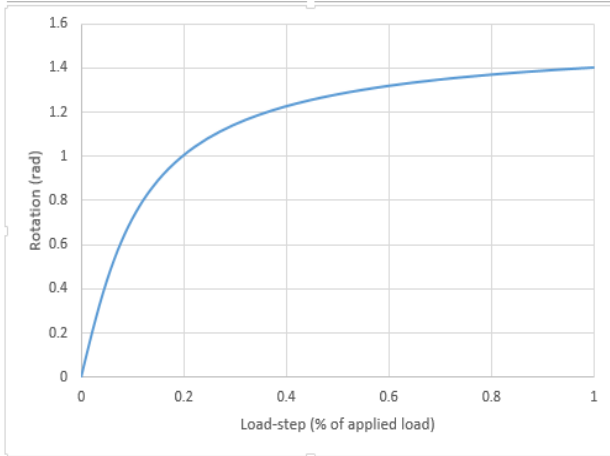
Figure 10: Rotation vs applied load for 2D Micro-model

The rotational stiffness ( $k_3$ ) of the micro model 2 was estimated to 8kNm/rad from the 3D-model. Like for the previous joint, the analyses for this model was not able to converge with the applied dynamic loads, and increasing the value of  $k_3$  did not improve the outcomes.
