# Behaviour of backfilled masonry arch bridges subjected to cyclic loading

Augusthus Nelson, L, Swift, GM, Smith, C, Gilbert, M and Melbourne, C

<b>Title</b>	Behaviour of backfilled masonry arch bridges subjected to cyclic loading
<b>Authors</b>	Augusthus Nelson, L, Swift, GM, Smith, C, Gilbert, M and Melbourne, C
<b>Type</b>	Conference or Workshop Item
<b>URL</b>	This version is available at: <a href="http://usir.salford.ac.uk/id/eprint/38896/">http://usir.salford.ac.uk/id/eprint/38896/</a>
<b>Published Date</b>	2016

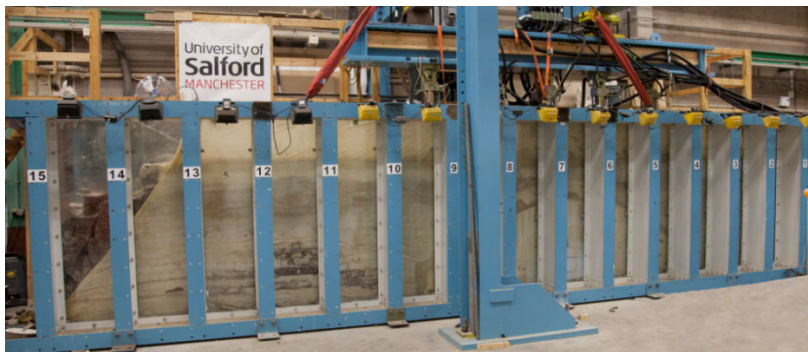
*Fig. 2. Masonry arch bridge test chamber located at the University of Salford.*

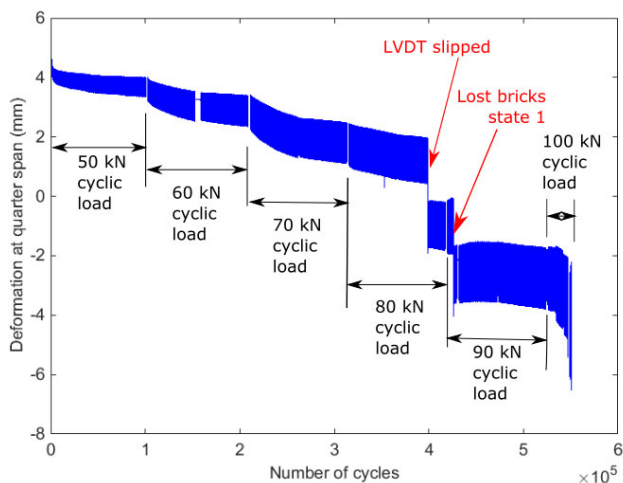
Figure 4 shows arch barrel deformation at the quarter span during the entire cyclic loading campaign on bridge EP5. Permanent deformation of the arch barrel and increases in the amplitude of deformation with higher cyclic load levels were observed as expected.

**Fig. 4.** Increase of displacement amplitude at the quarter span against number of cycles –EP5.

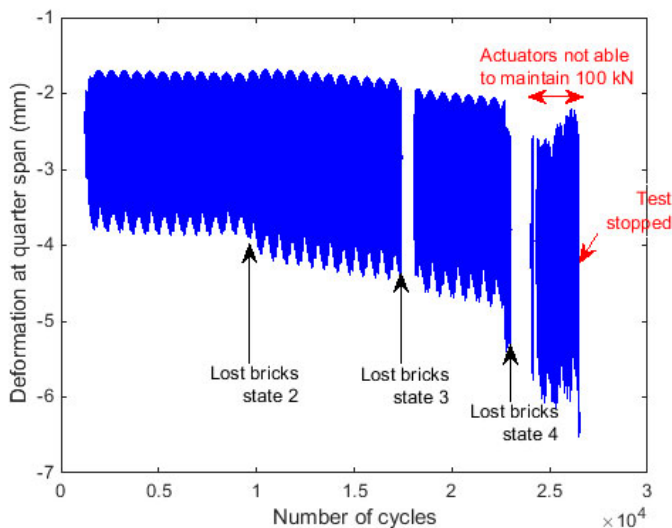
**Fig. 5.** Increasing the quarter span displacement amplitude vs. number of cycles under the action of a 100 kN cyclic load –EP5.

The arch barrel deformed significantly at the start of 100 kN cyclic loading stage. At around  $10^4$  cycles, bricks fell out at the crown (denoted state 2 in Figures 5, 6 and 7). Immediately afterwards the amplitude of the arch deformation increased by approximately 0.5 mm at the quarter span. Further bricks were lost at the crown at around  $1.7 \times 10^4$  cycles (state 3) and at  $2.3 \times 10^4$  cycles (state 4). Immediately after state 4, the loading actuators were not able to reach the peak load of 100 kN due to significant reduction in the stiffness of the bridge. (This was because the hydraulic pump was unable to supply oil at a sufficient rate to maintain the desired cyclic loading regime.)

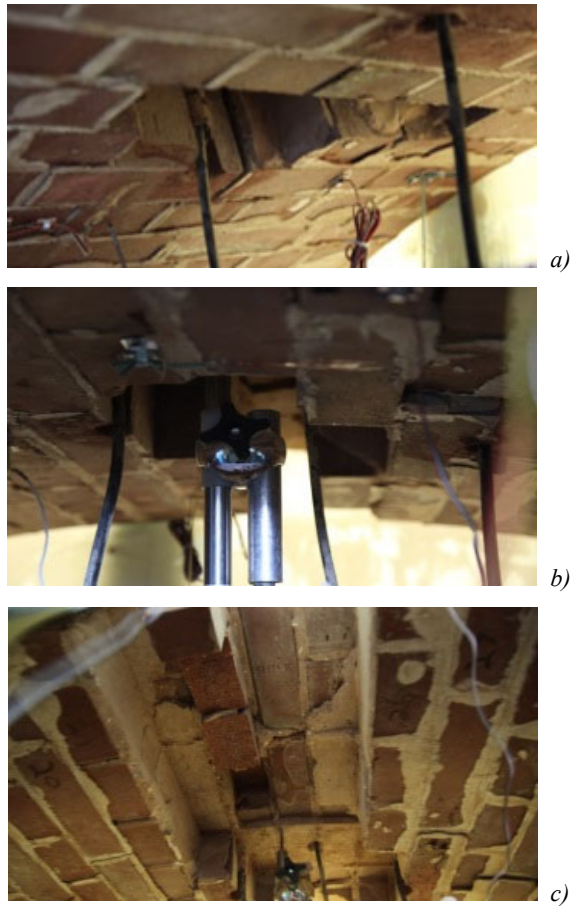
**Fig. 7.** Lost bricks at: a) state 1, b) state 2, and c) state 3 and 4.
